Rocky Flats Environmental Technology Site  
Golden, Colorado

**Rocky Flats Environmental Technology Site**  
**Golden, Colorado**  
**INTEGRATING CONTRACTOR, KAISER-HILL L.L.C.**

**Demolition, Decontamination and  
Decommissioning (D&D) Projects,  
Deactivation Projects,  
and Remediation Projects  
In-Progress, Planned, or Completed  
for the  
Rocky Flats Environmental Technology Site**

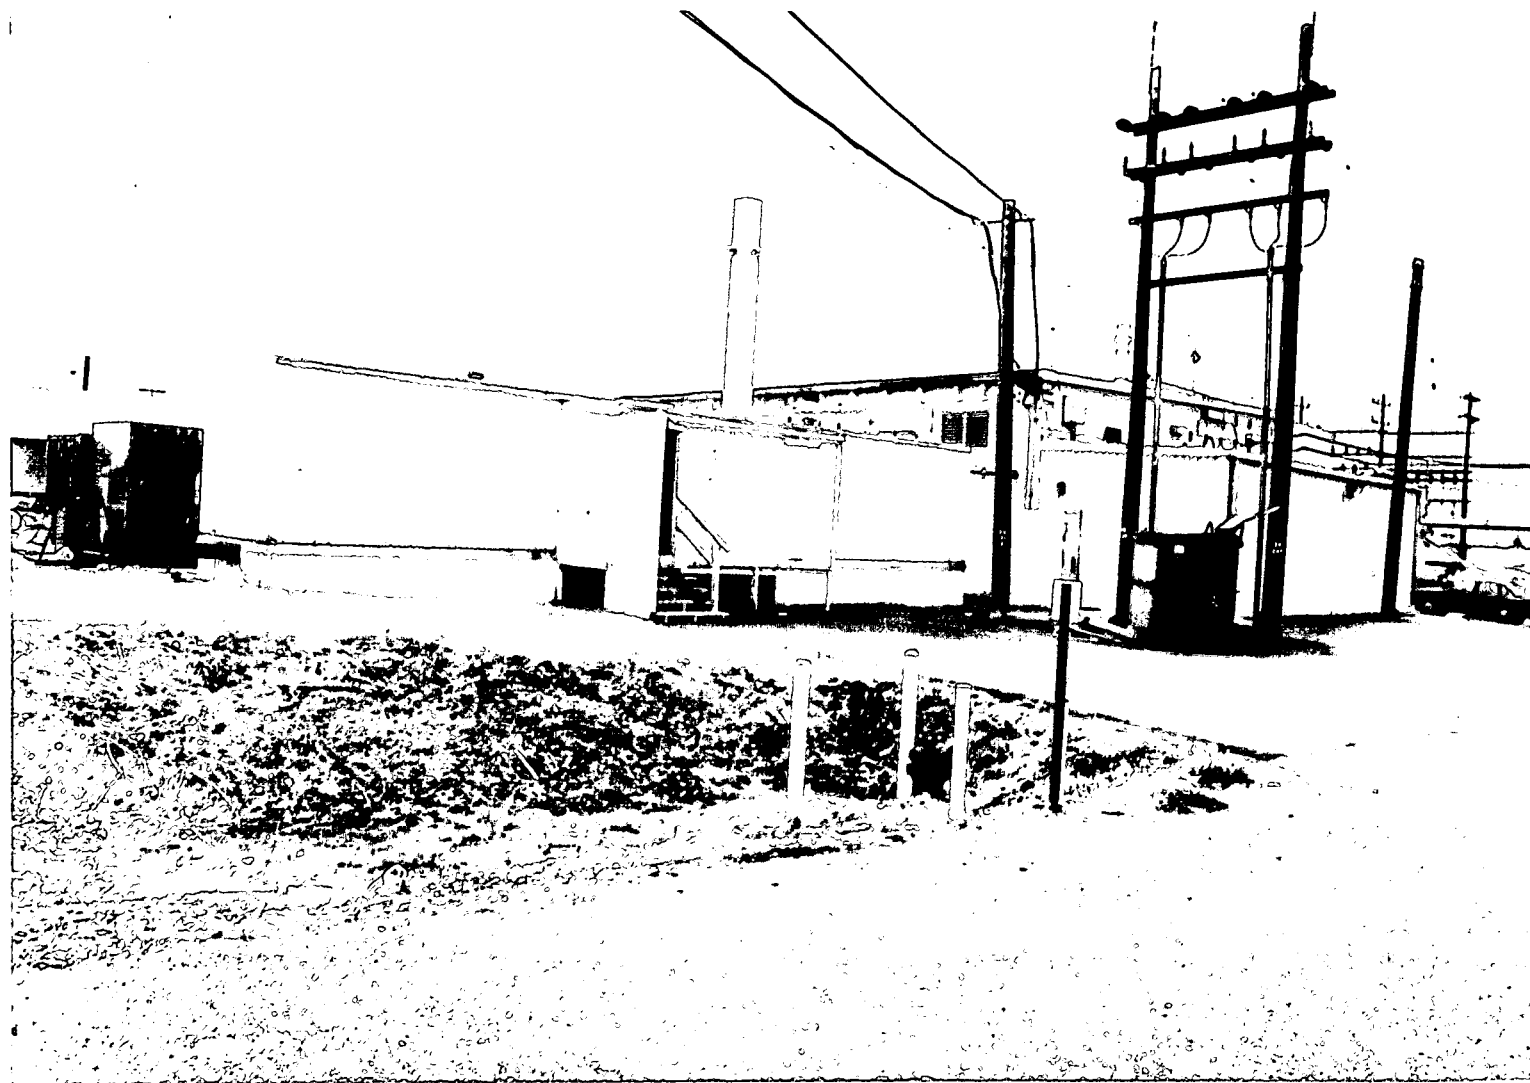
**Figure 30:** (before) This picture is the shower trailer that will be removed from inner plantsite to Property Utilization and Disposal (PU&D) storage site for future usage determination.

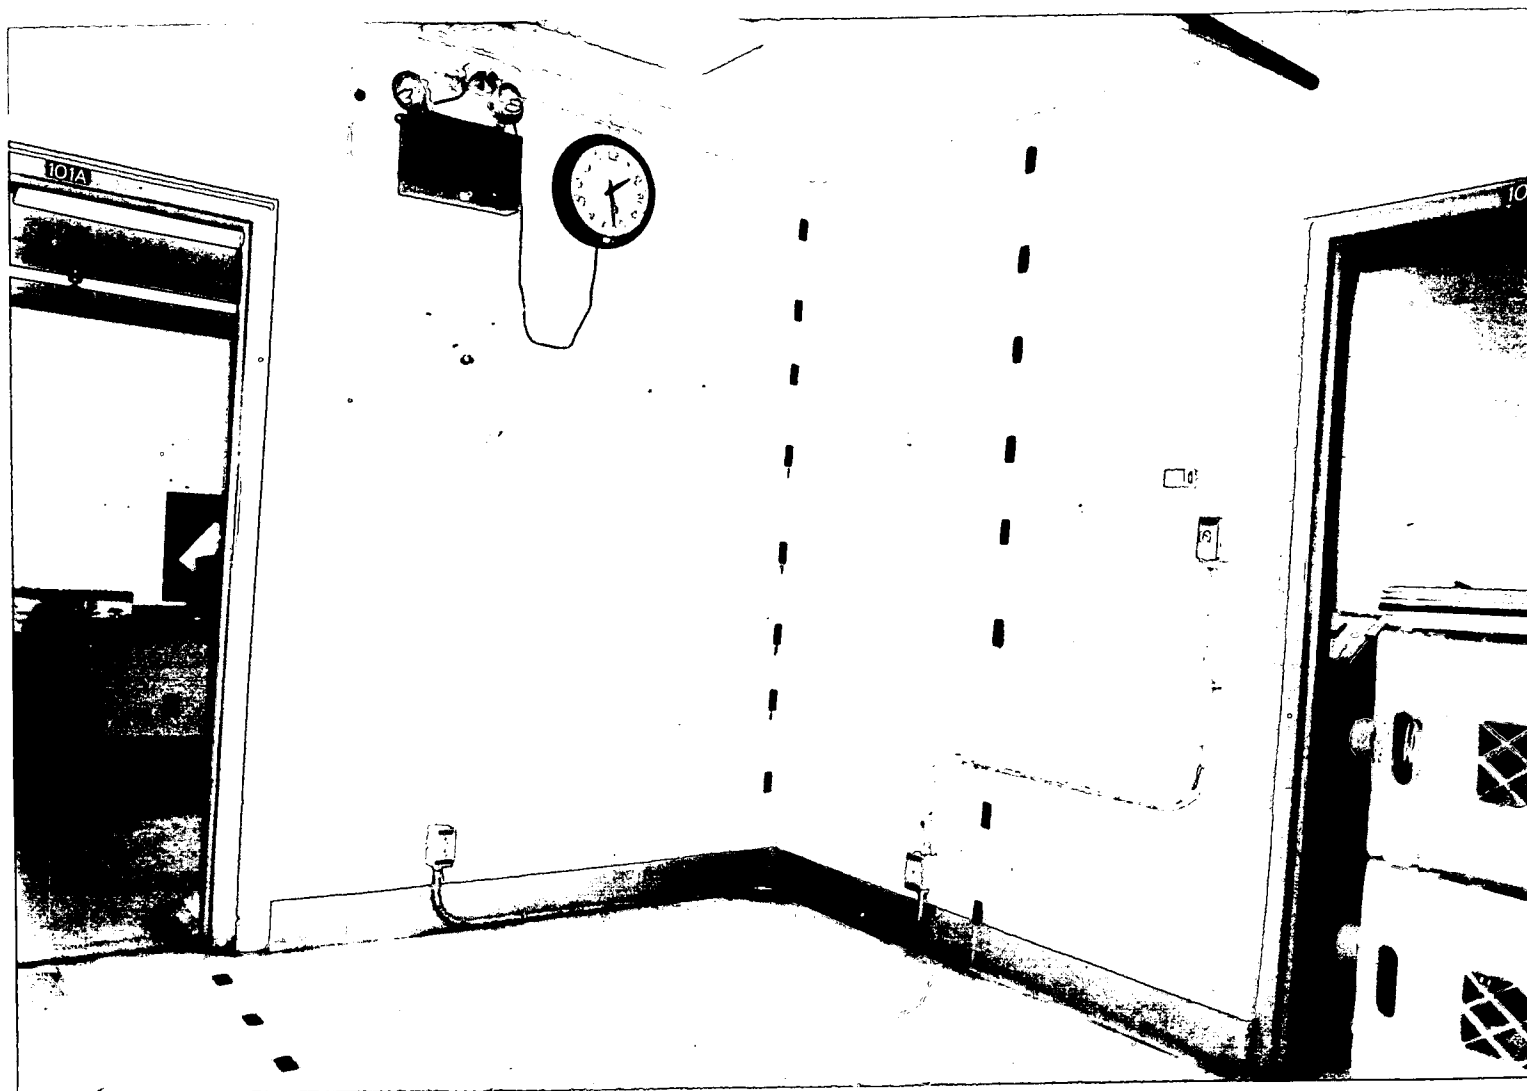
**Figure 31:** (before) An office area view inside of Building 889 that is gridded for hazard constituents characterization e.g., Pb, Ur, Asbestos, Be, etc. The entire building will be gridded, and samples will be taken for verification prior to demolition.

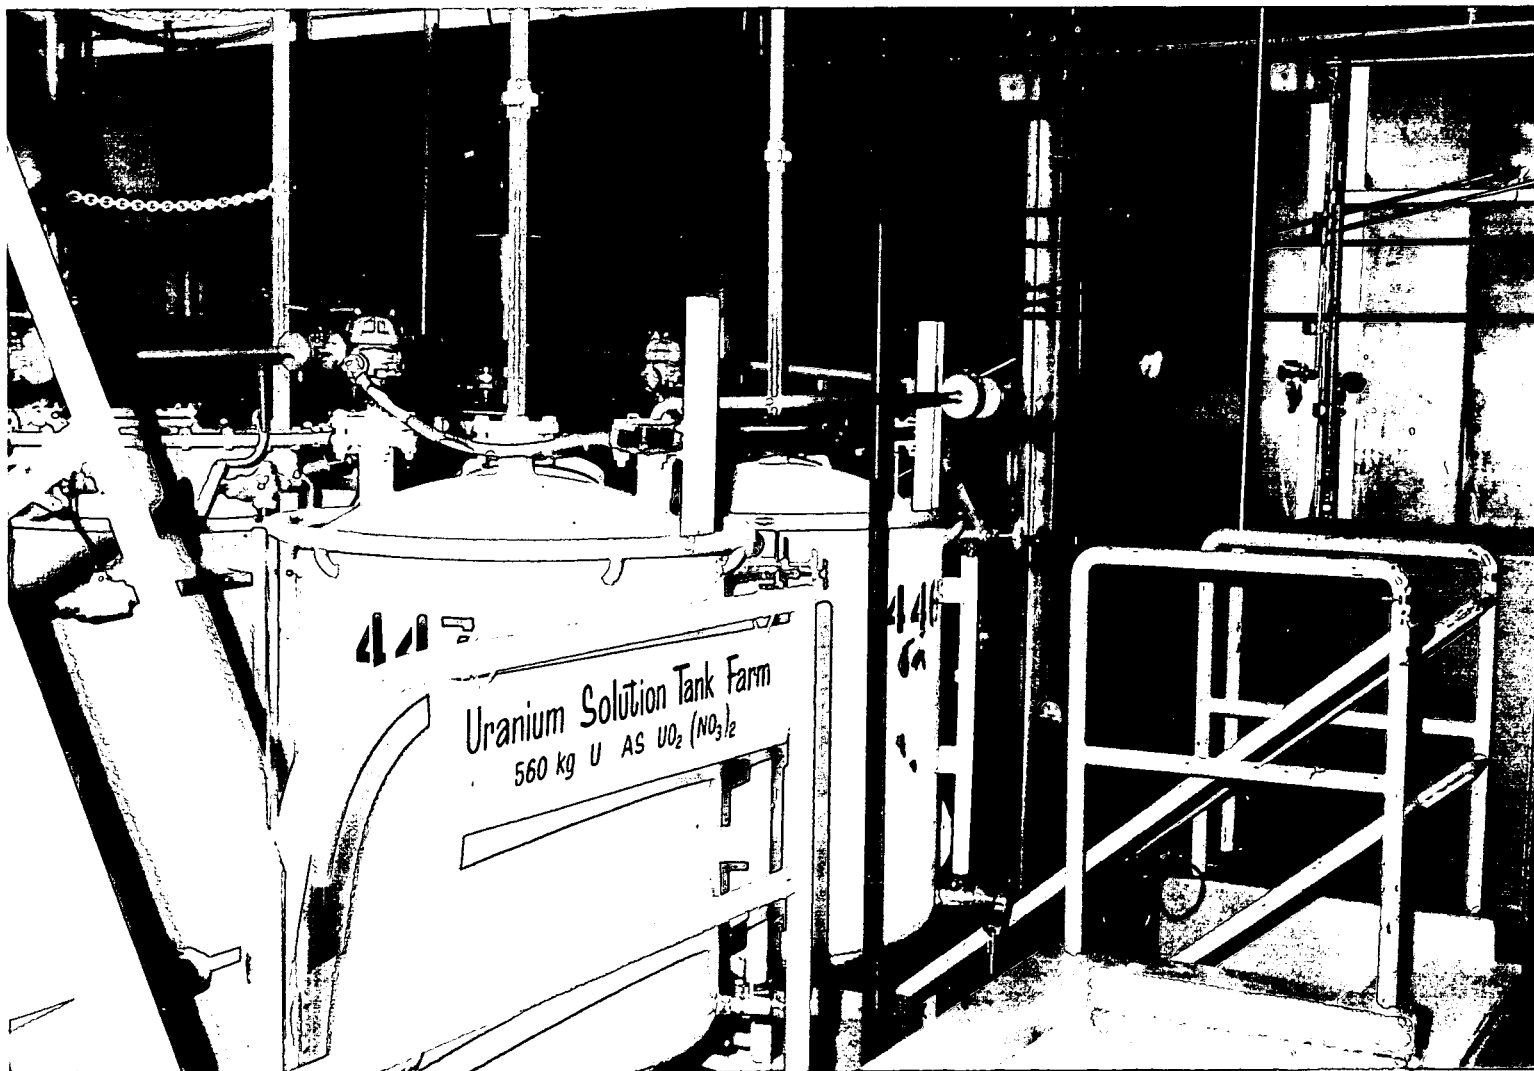
**Figure 33:** (before)Rm 103 HEUN Storage Tanks. Raschig Ring Tanks will be cleaned and closed.

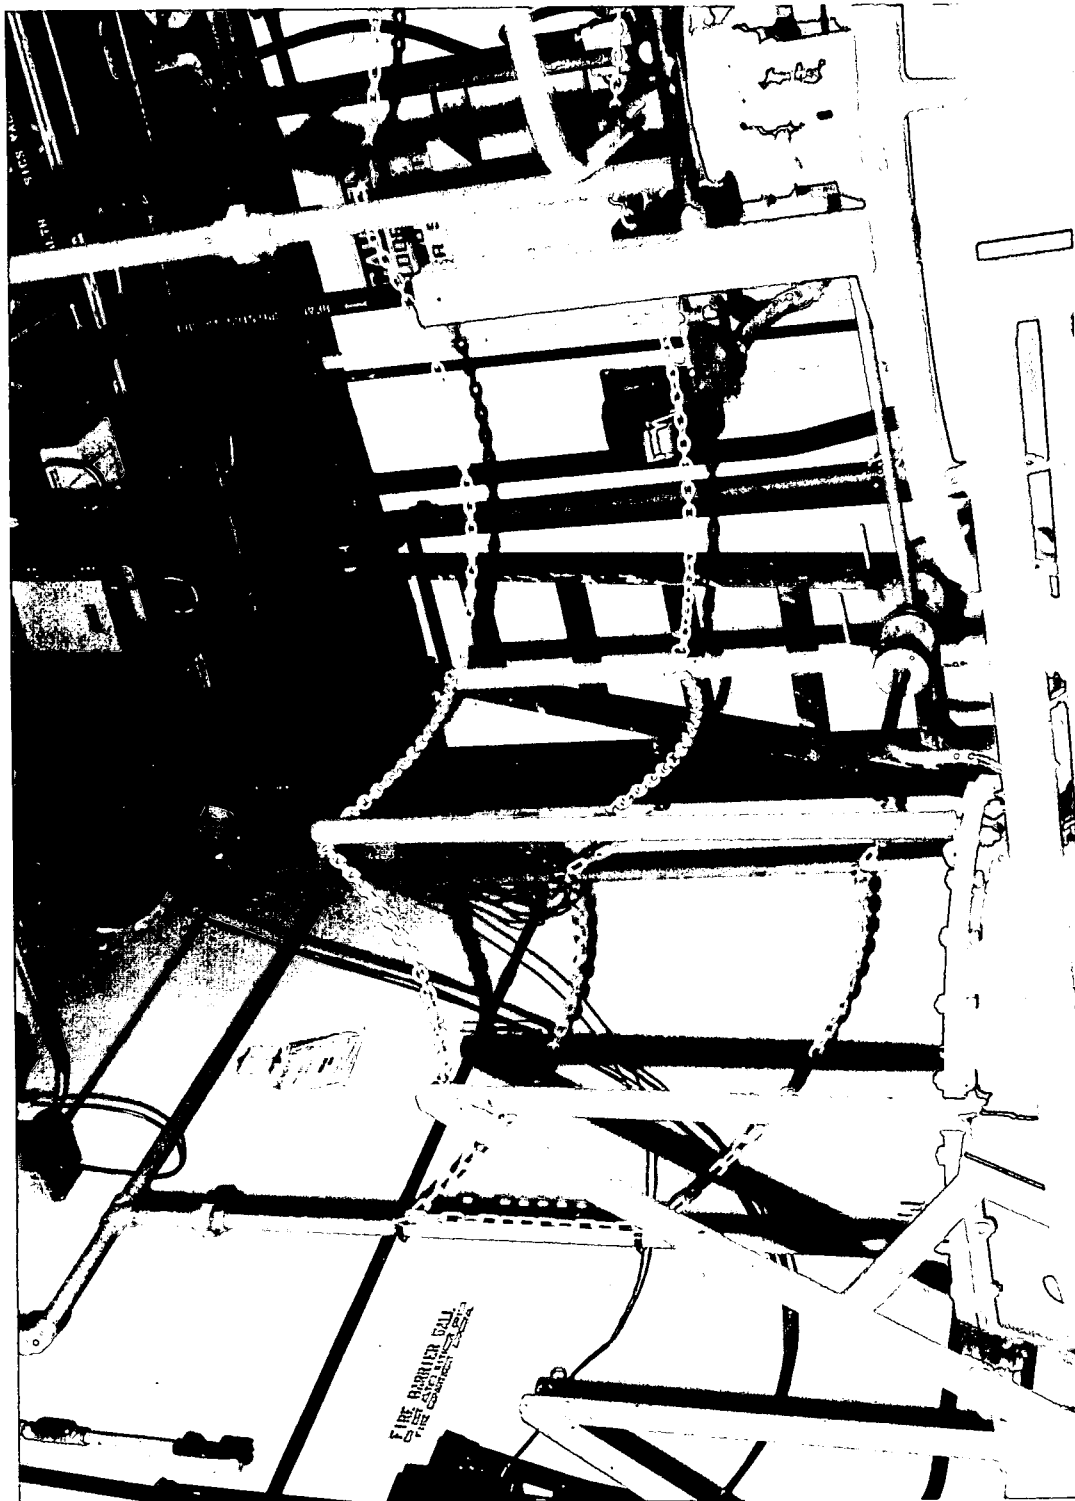
Figure 34: (before) Overhead of Rm 103, contaminated with Uranium.

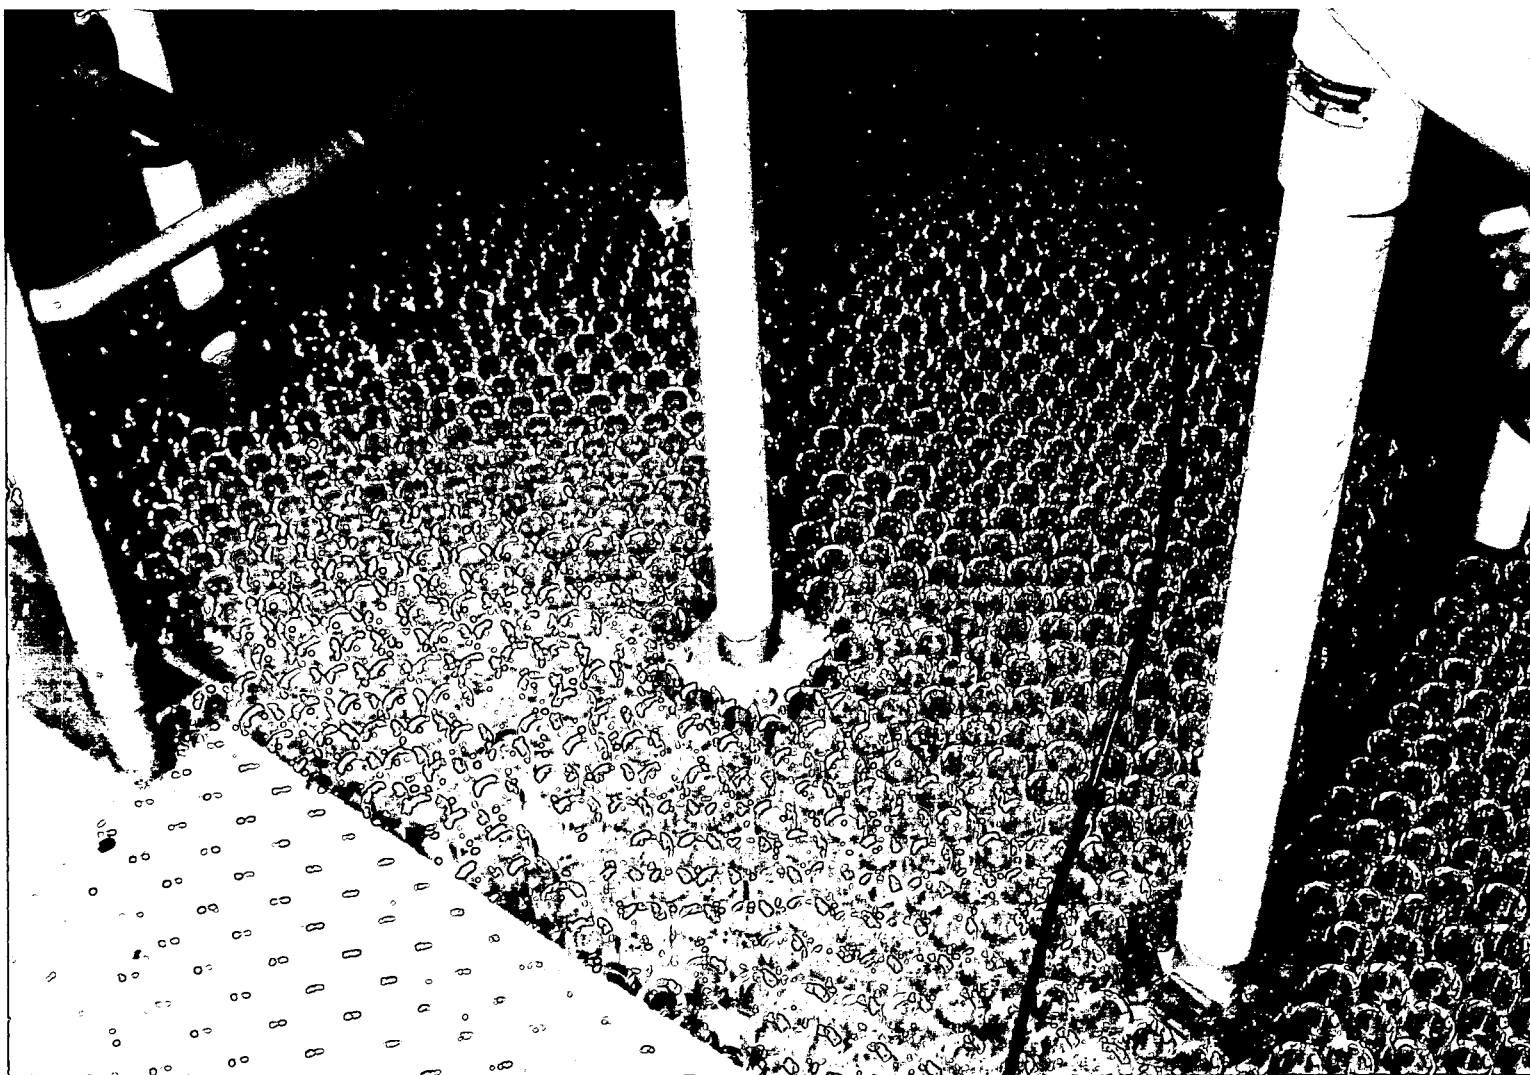
**Figure 35:** (before) Floor in Pit Area of Rm 103, contaminated with Uranium and trace amounts of Plutonium.

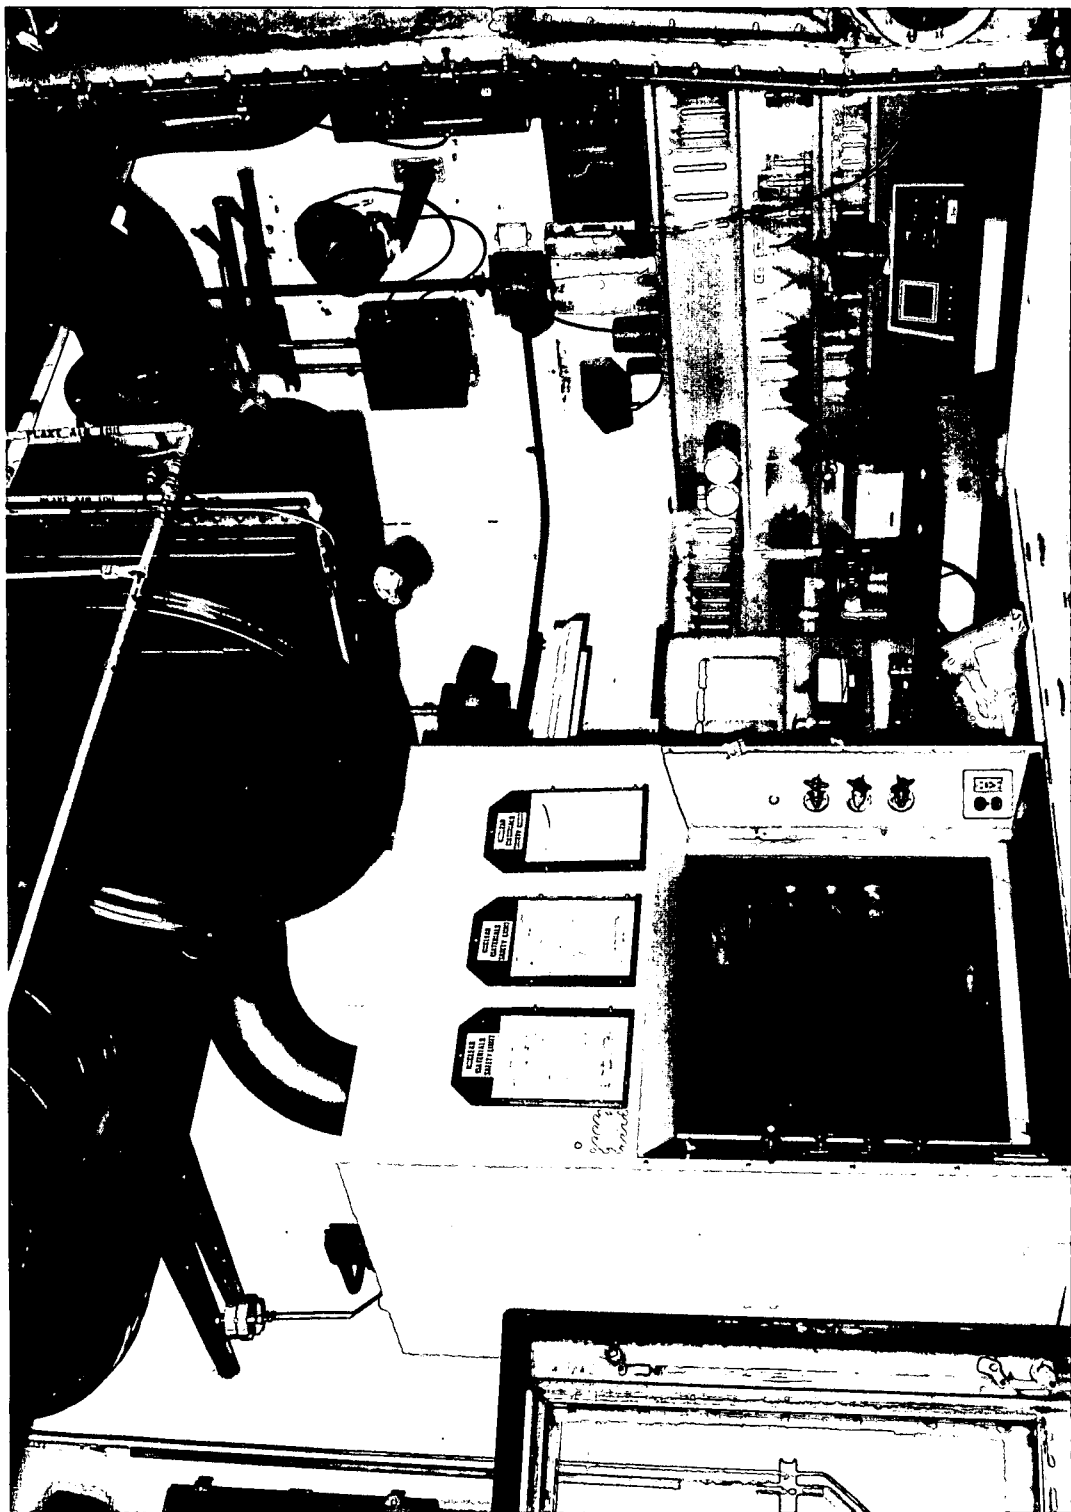
Figure 36: (before) Rm 103 mezzanine. Hood is contaminated with both Uranium and Plutonium holdup.

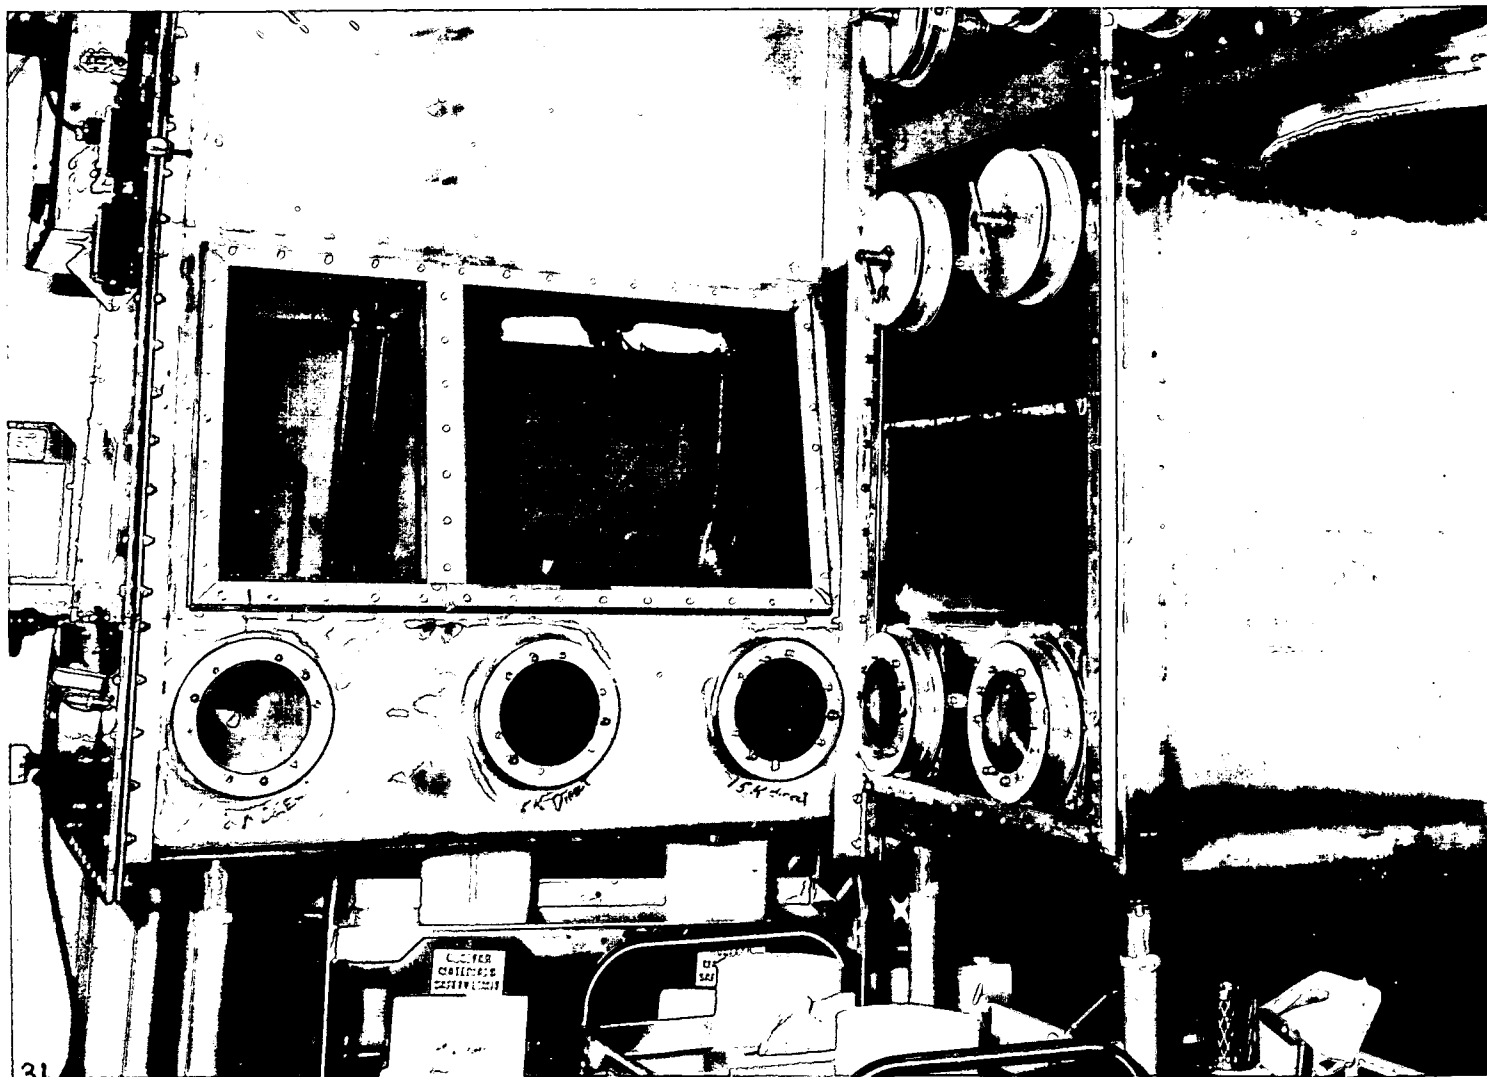
**Figure 37:** (before) Rm 103 Glovebox and downdraft in Rm 103 contaminated with Plutonium holdup.
